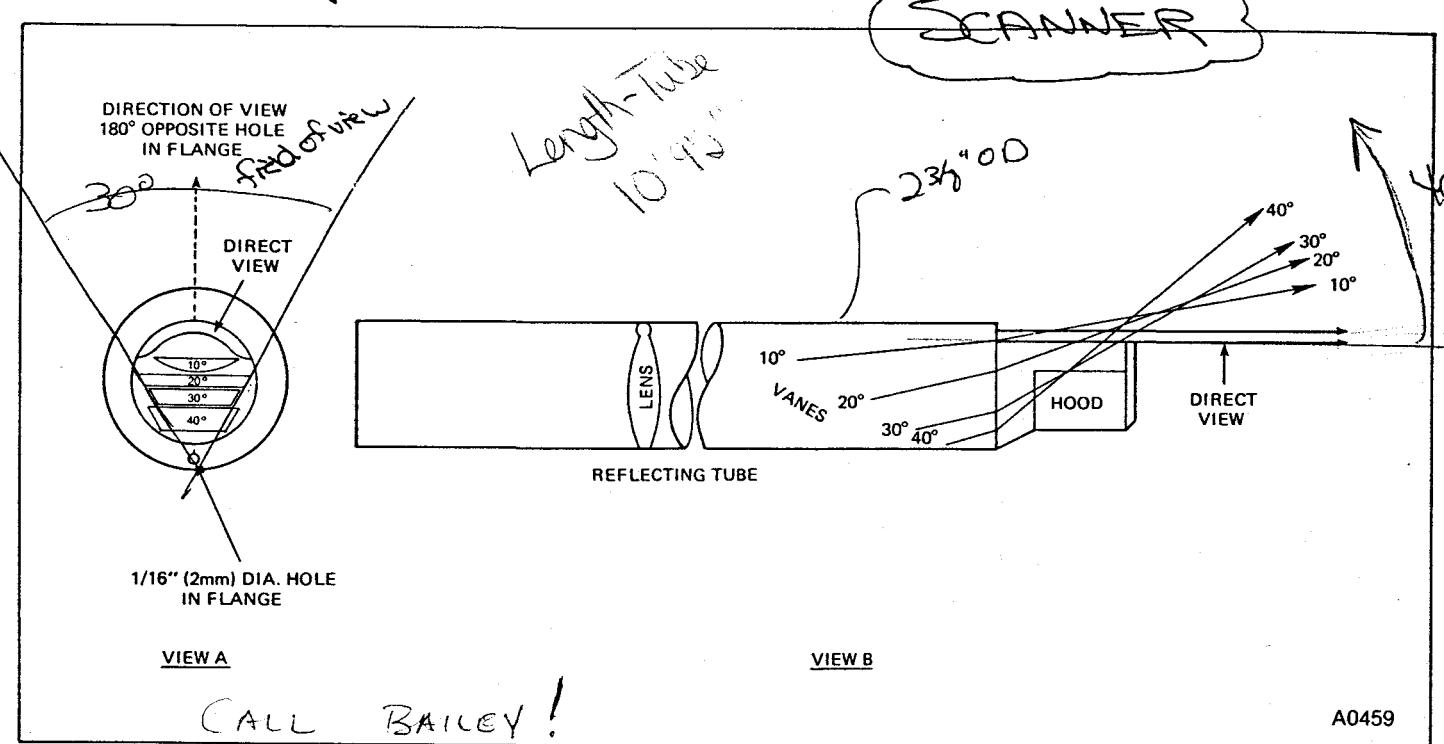
FIGURE 17 — Reflecting Vanes

9. Continue to slide the detector assembly into the furnace until all vanes become bright. At that point, insert the assembly an additional two inches to ensure good exposure of all vanes.

Maximum temperature at the hot end of the detector assembly must not exceed 640° F (338° C). Higher temperatures will damage the reflecting vanes and/or fiber optics.
